Manhole Inspection Summary

Manhole # S49I__025MH

Insp Date: **3/28/08 9:52 AM**

Location Address: **508 Pfister Ct**

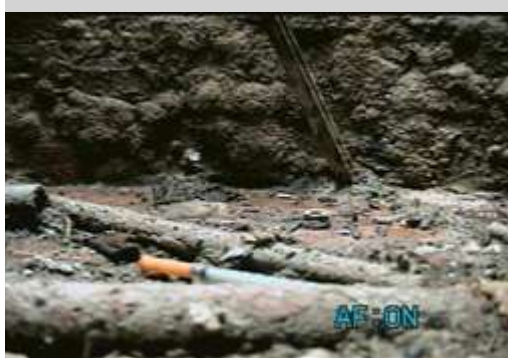
Misc.

bench debris

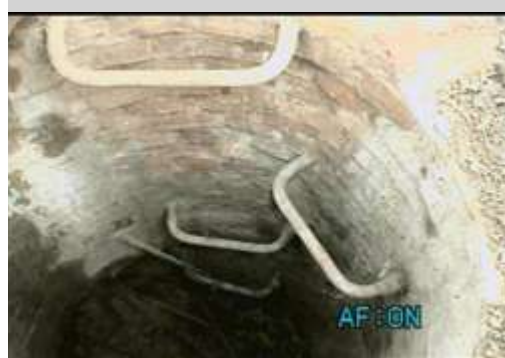
Defect 2

Infiltration: ☐ None ☐ Joint ☐ Cracks ☐ Mortar ☐ Roots ☒ Wall

Count: **4** Missing: **0** ☒ Corroded

steps corroded, infiltration in corbel wall

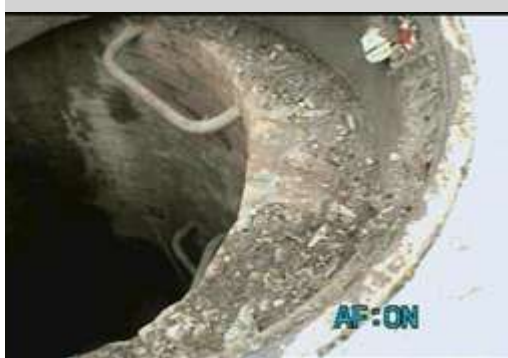
Defect 1

Offset: **5** (in.)

frame offset 5 inches

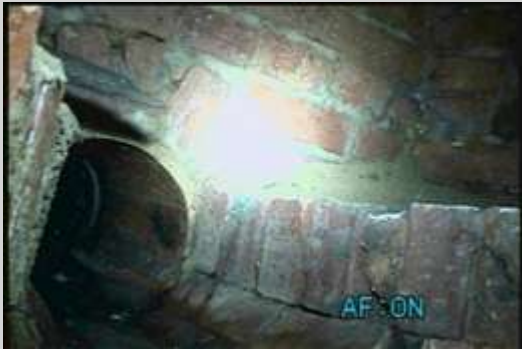
12 O'Clock Outflow

offset frame makes it difficult to get pics straight

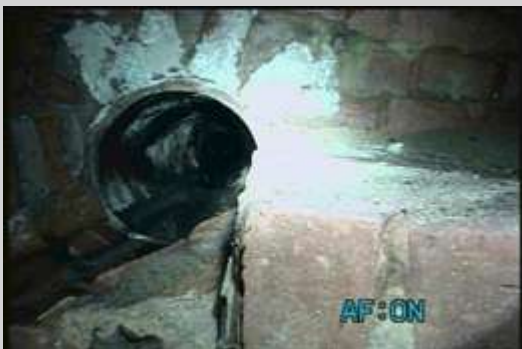
3 O'Clock Inflow

offset frame makes it difficult to get pics

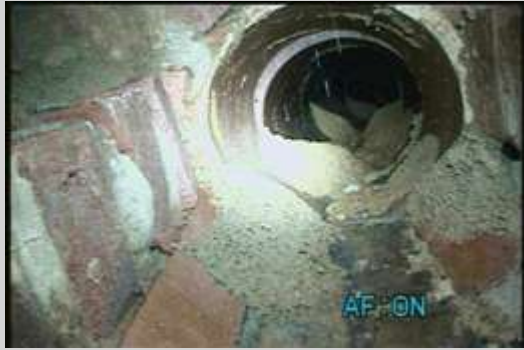
6 O'Clock Inflow

Deposits: ☐ None ☐ Mud ☐ Sludge ☒ **Debris** ☐ Grease

Silt Depth: 0 (in.) Deposits Extent: **Light**
